WATERSHED ASSESSMENT/RESTORATION PLAN

Rasler Run is a scenic mountain stream that flows off the eastern slopes of Chestnut Ridge into Indian Creek approximately 2.5 miles upstream from the confluence of Indian Creek with the Youghiogheny River. Reports from local anglers of naturally reproducing populations of native brook trout as well as non-native rainbow trout have been confirmed by the Pennsylvania Fish and Boat Commission. These trout populations may be in jeopardy of being lost if long term plans are not made to protect this watershed. Therefore, it is the goal of this project to gather pertinent background information on the Rasler Run watershed in order to “*identify potential problems & opportunities for stream conservation*” as is stated in the Coldwater Heritage Partnership grant application for Coldwater Conservation Plans.

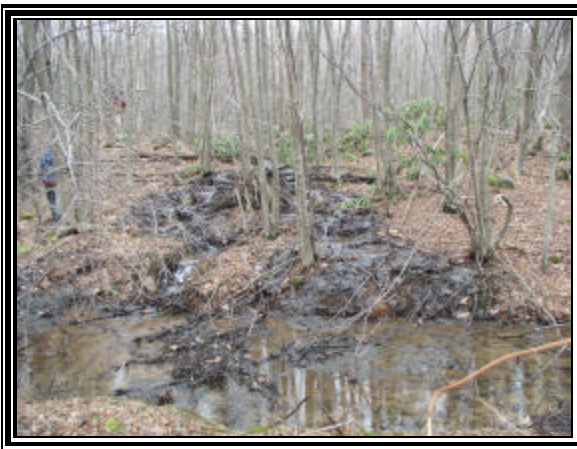
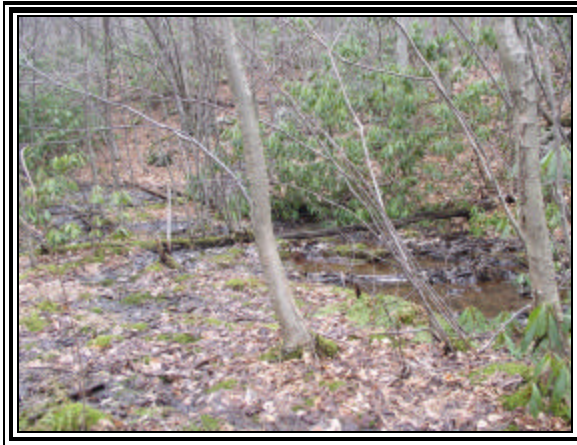
Photos of discharges in northern end of Rasler Run

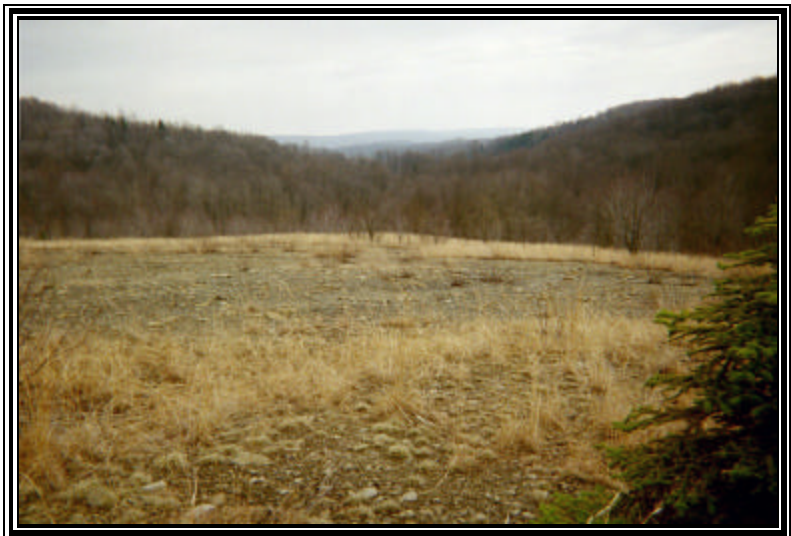
The primary site of concern is located in the headwaters of the stream and can be seen in the adjacent photograph. The photograph reveals the rather typical look of an insufficiently covered AML site. Note the exposed areas and sparse low growing vegetation. The FCCD recommends that the landowners of this site and sites like it be contacted regarding the possibility of re-planting the site with a diverse range of trees and shrubs.

Photo of AML Site in Headwaters of Rasler Run

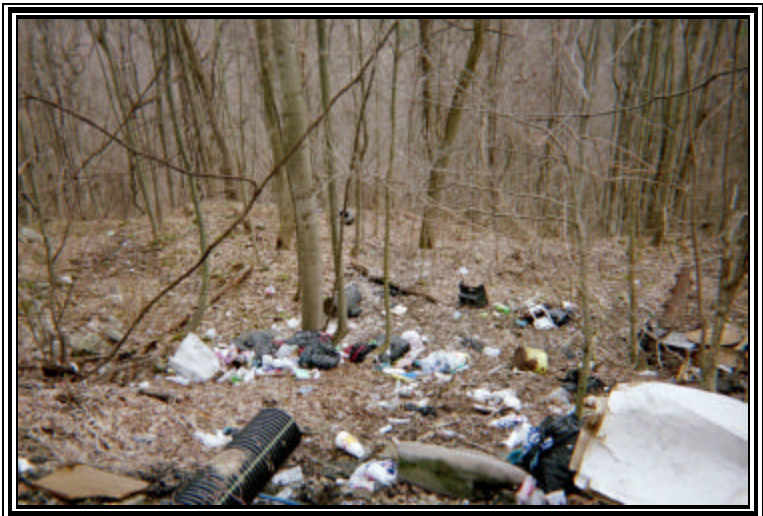
Illegal dumps can be found sporadically throughout the Rasler Run Watershed. Due to the highly rural nature of the watershed, people have scattered small dump sites in the more remote areas, like near where Rasler Run confluences with Indian Creek.

Photo of Illegal Dump near the mouth of Rasler Run

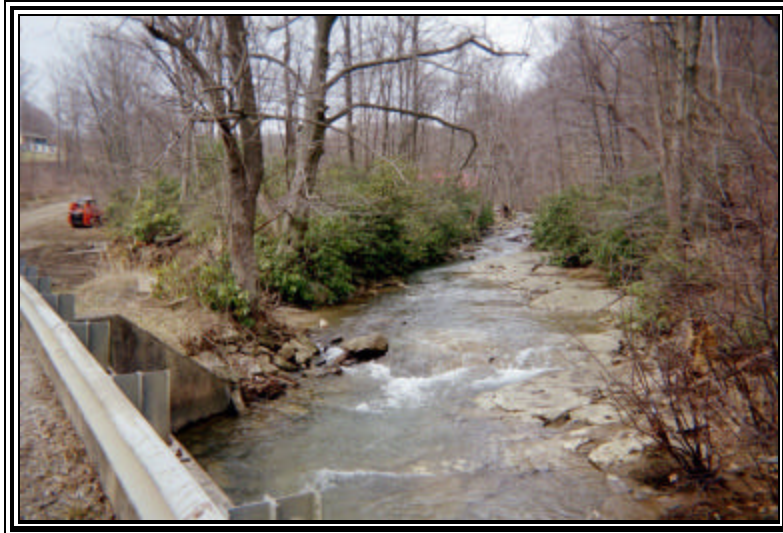
Photo showing where sediment can enter Rasler Run
the problem.

Efforts should include a thorough habitat assessment on its own or as a part of a complete and detailed watershed assessment (please reference Section V – General Recommendations). Areas where streambank erosion is occurring should be identified, mapped and studied as how to repair them. This would include looking for factors within the watershed which may be causing or contributing to

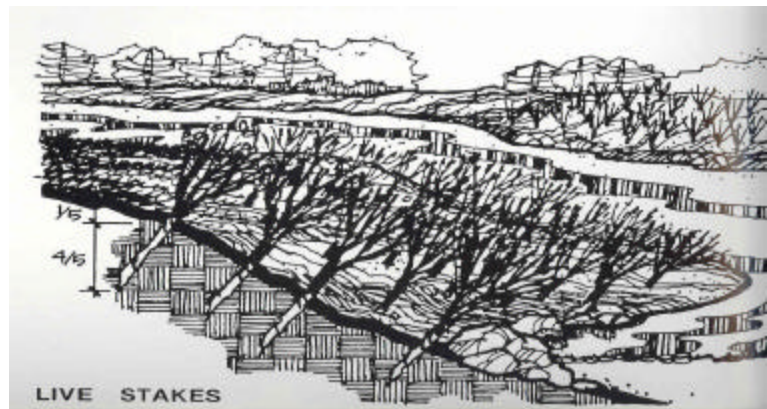
Live Stakes

The first method we will tackle is the method of live-stakes. Live-stakes are living woody plant cuttings capable of quickly rooting in the streamside environment. These stakes are usually dogwood or willow cuttings that will form a quick plant cover. This method is most useful on moderate slopes

(4:1 or less); to be used in original bank soil not in fill; is most effective where soil erosion is light; is most effective where it is used in combination with other techniques and is applicable on all sizes of streams. This method is a very effective stabilization method once vegetation is established and works well when time is limited. It can also be an ef-

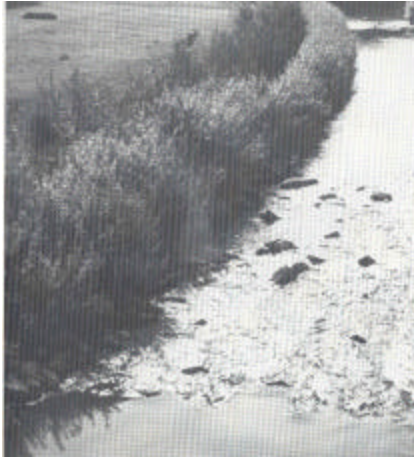
Live Fascines/Bundles

Method two is the live fascines or bundles method. Live fascines are log like bundles of live cuttings wired together and secured into the stream-bank with live or dead stakes.

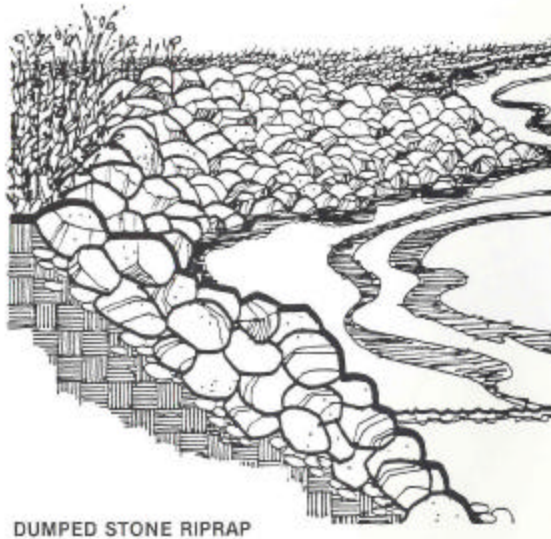
Stone Riprap

Another method is the stone riprap method, which is a technique that substitutes rock for earth on the banks of a stream. Riprap covers the banks with a layer of stone at an angle that approximates the natural slope of the streambanks. It is best used on small to medium size streams and shaded areas where it could be difficult to grow woody vegetation. This technique can also be used in combination with cuttings to provide initial stabilization while the vegetation takes hold. Riprap streams with water and on actively eroding banks at rough curves. Due to the rough texture of riprap, it will absorb some energy and decrease its velocity. Riprap in stabilizing actively eroding streambanks and can also blend in with the landscape.

approximates the natural slope of the streambanks. It is best used on small to medium size streams and shaded areas where it could be difficult to grow woody vegetation. This technique can also be used in combination with cuttings to provide initial stabilization while the vegetation takes hold. Riprap streams with water and on actively eroding banks at rough curves. Due to the rough texture of riprap, it will absorb some energy and decrease its velocity. Riprap in stabilizing actively eroding streambanks and can also blend in with the landscape.

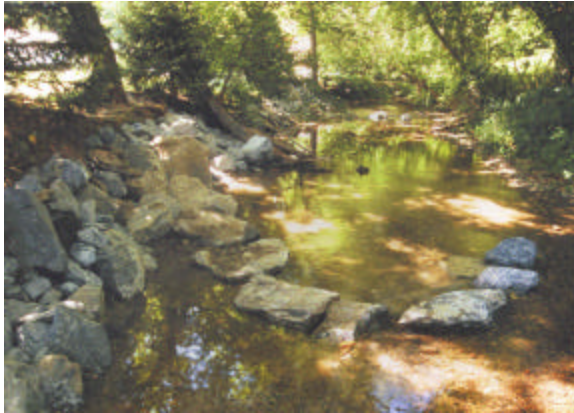
J Hooks/J Vanes

A method that has come into wide use in the past few years is the fluvial geomorphic technique of J hooks or J vanes. These structures are rock vanes that have a hook on the

stream end to help center the flow rolling over it. The J hooks help to direct the bankfull flow away from

stream banks and provide habitat by creating a scour. With the typical application of J hooks and rock vanes, they are placed on the curves of the stream to control the curvature of the

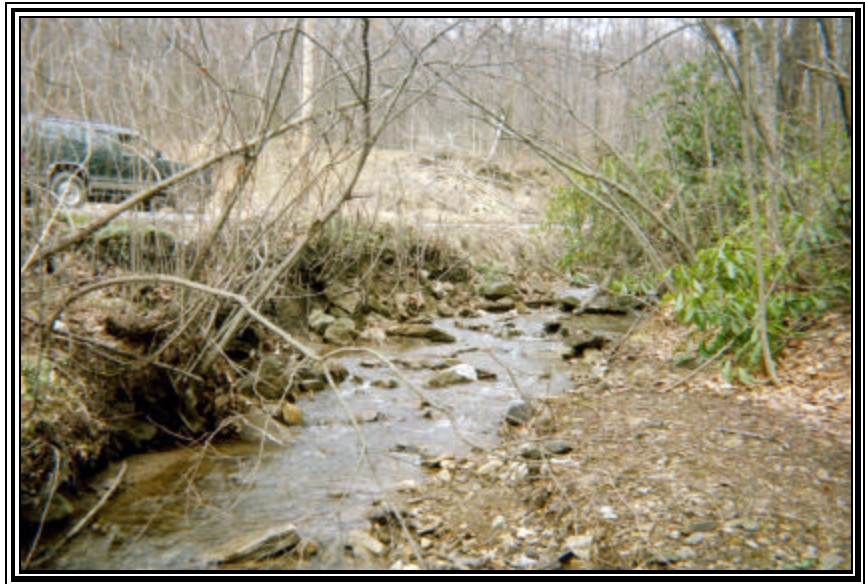
Photo showing streambank erosion along Rasler Run
