Upper Toby Creek Coldwater Conservation Plan

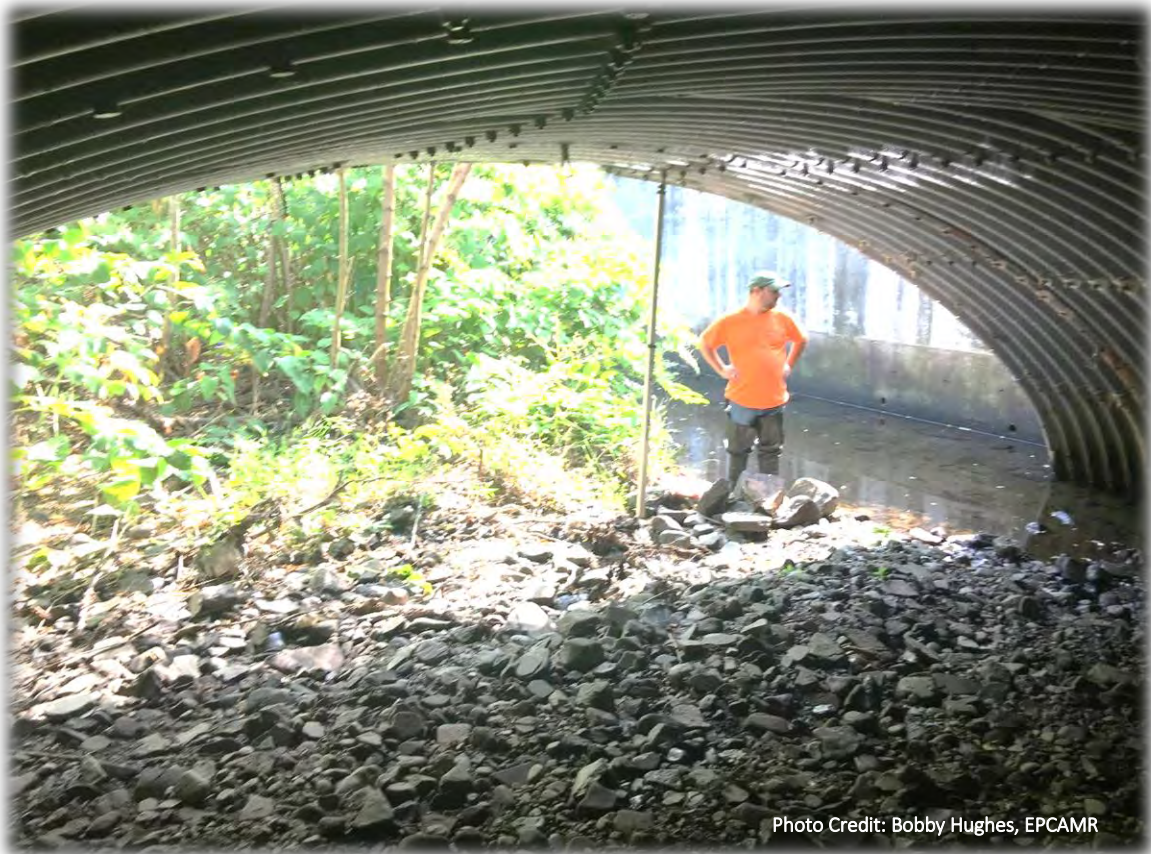
Figure 7. Tom Mayka, DAMA Stormwater Coordinator surveying the conditions of Toby Creek at outlet of the large corrugated metal culvert east of Dunkin Donuts on the Dallas Memorial Highway before conducting the AOP Assessment.

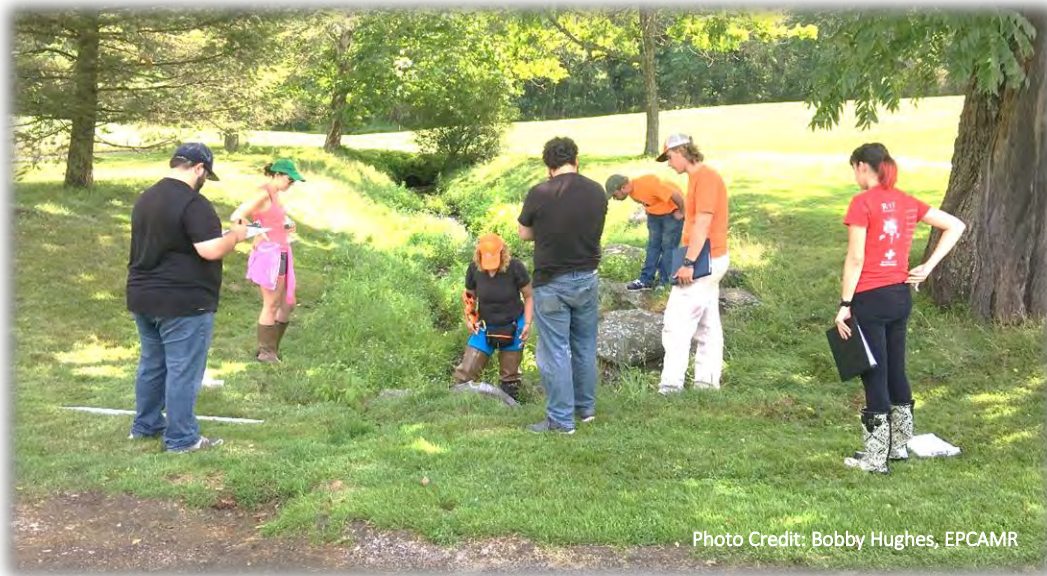
Figure 8. EPCAMR and DAMA Staff perform an AOP Culvert Assessment/Training at tributary on the Irem Country Club Golf Course

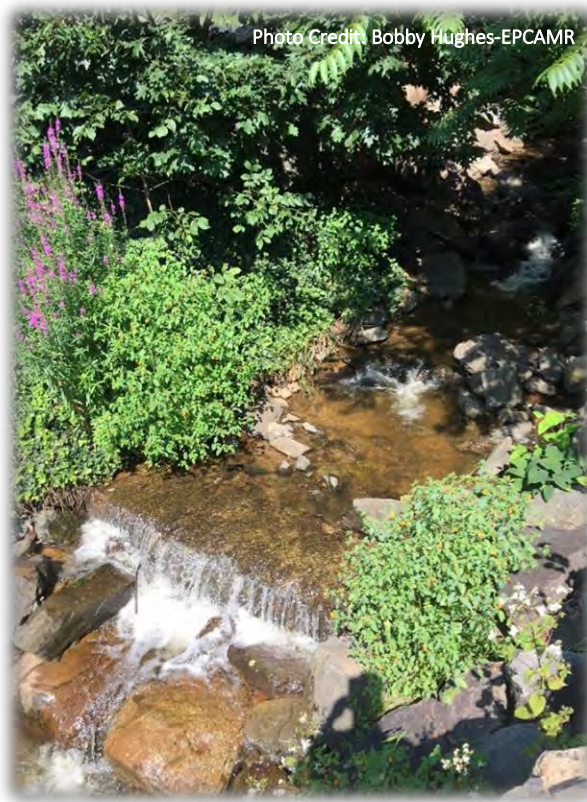
Figure 9. Wildcat Falls, unnamed tributary to Toby Creek flowing over concrete encased sewer line

The unnamed tributary has a sewer line that is encased with concrete that crosses it and enters the DAMA Plant. There is an approximate 2’ vertical drop within the stream channel at a concrete encasement that is about 8-10’ wide. There is a culvert that runs in a southeasterly direction under the DAMA Plant road before exiting into Toby Creek’s left streambank looking downstream. The outlet to the culvert is located on the other side of the DAMA property fence. The area can only be accessed from an upstream point on Toby Creek, where two very large culverts are located at the other end of the DAMA Plant property. Japanese knotweed³², an invasive plant that is very common throughout the Wyoming Valley streambanks, is prevalent along both banks looking upstream and downstream, along Toby Creek.

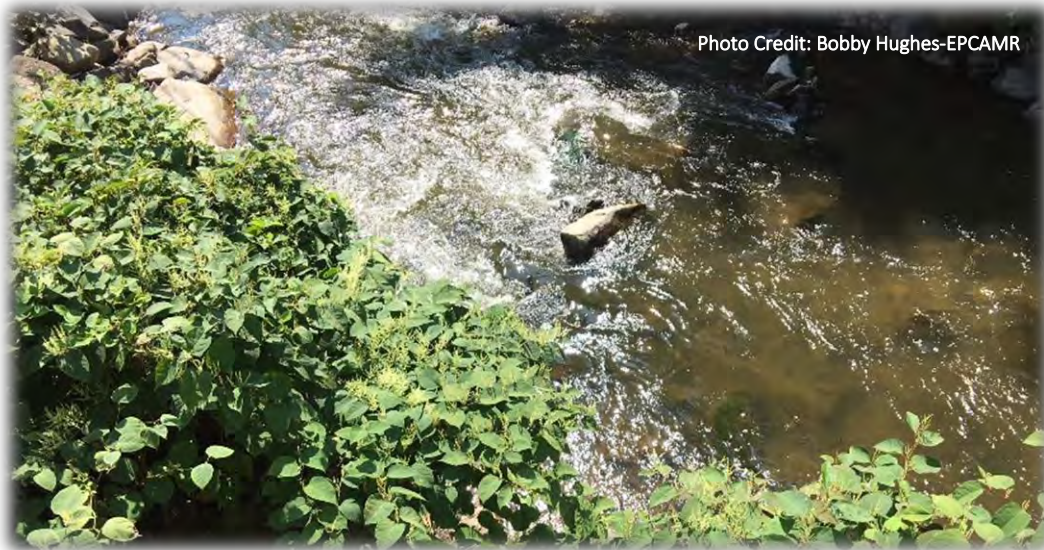
Figure 10. “Wildcat Falls” tributary flowing into Toby Creek, where Japanese Knotweed, is pervasive, downstream from DAMA parking lot

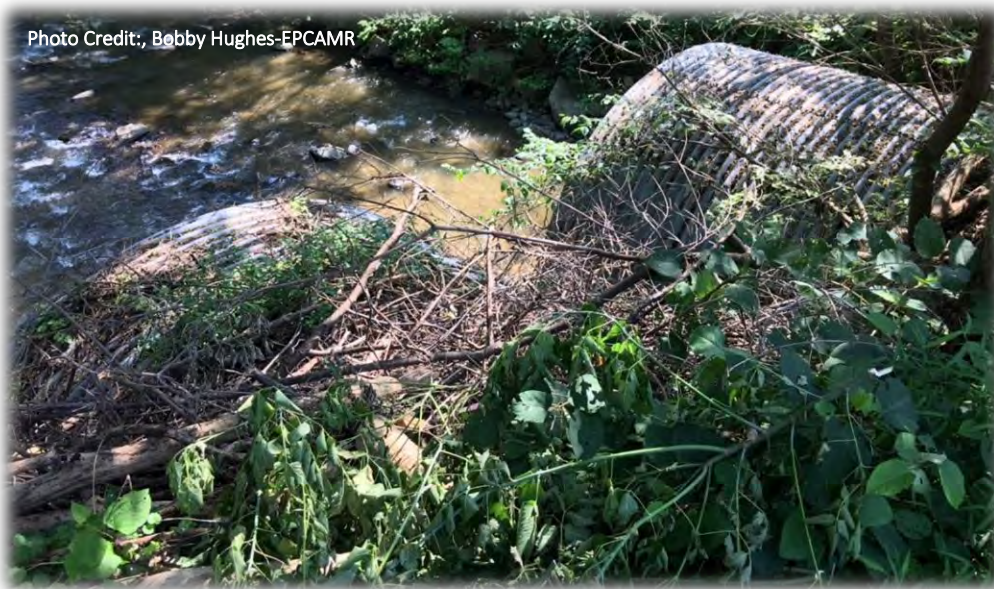
Figure 11. Double Metal Corrugated Squashed Pipes directing flow of Toby Creek under State Route 309 adjacent to the DAMA

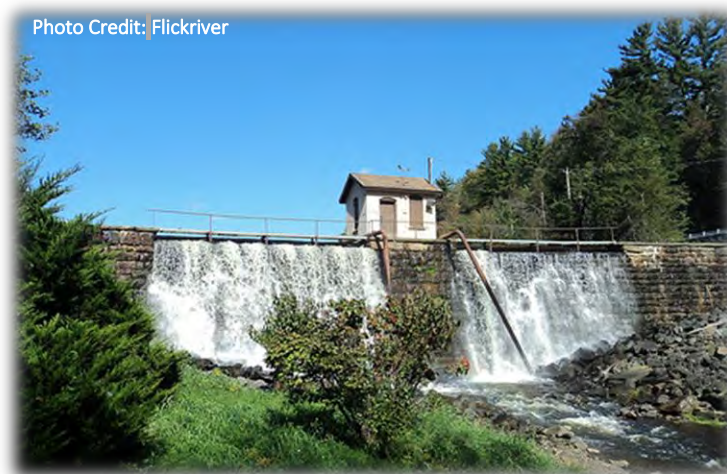
Figure 13. Overflow from the Huntsville Dam in the Huntsville Creek subwatershed of larger Toby Creek Watershed³⁶

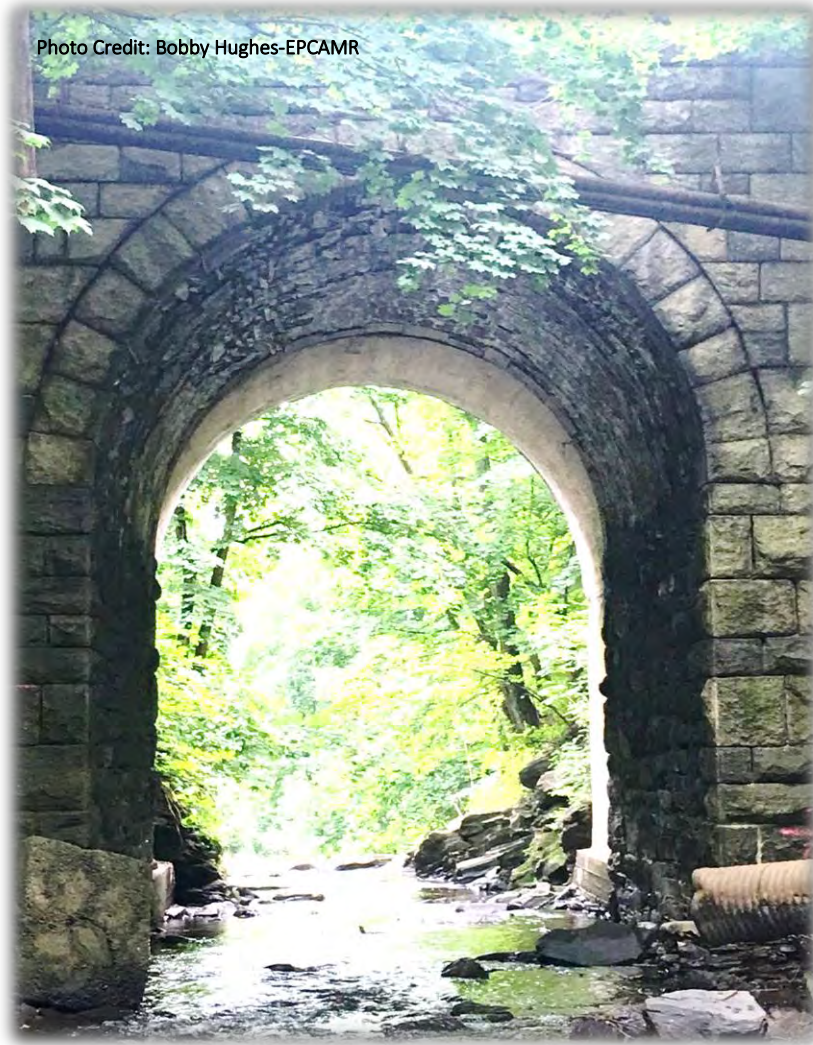
Figure 15. Toby Creek flows downstream through the Stone Arch Bridge over Harris Hill Road

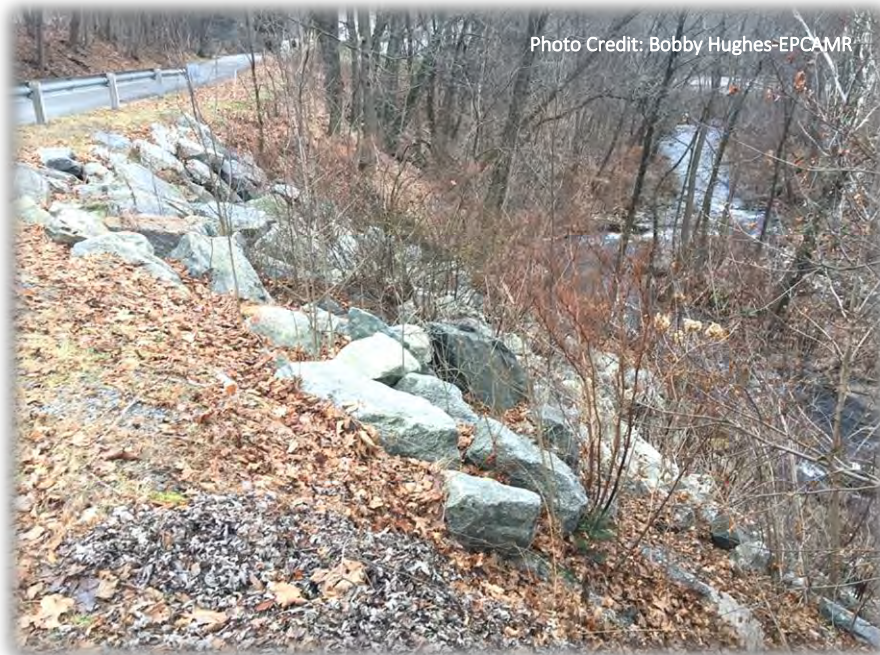
Figure 16. Streambank project completed on Toby Creek by Luzerne Conservation District and partners below Harris Hill Road

A large streambank stabilization project was completed by the Luzerne Conservation District near the steep bank looking downstream from the stone bridge where the second arch was historically located under a Pennsylvania Department of Environmental Protection (PA DEP) Growing Greener Grant.

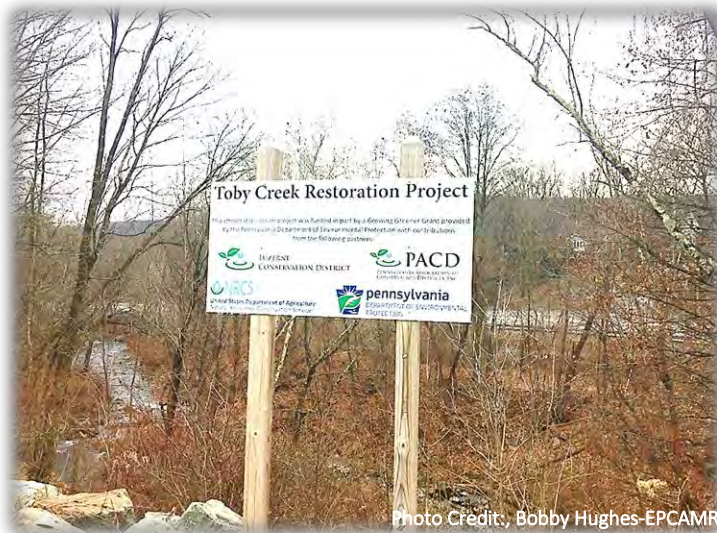
Figure 17. Toby Creek Restoration Project completed by the Luzerne Conservation District and partners
