# **Coldwater Heritage Partnership Implementation Grant Final Report Morrison Run Watershed Restoration Project Western Pennsylvania Conservancy**

## **Project Summary**

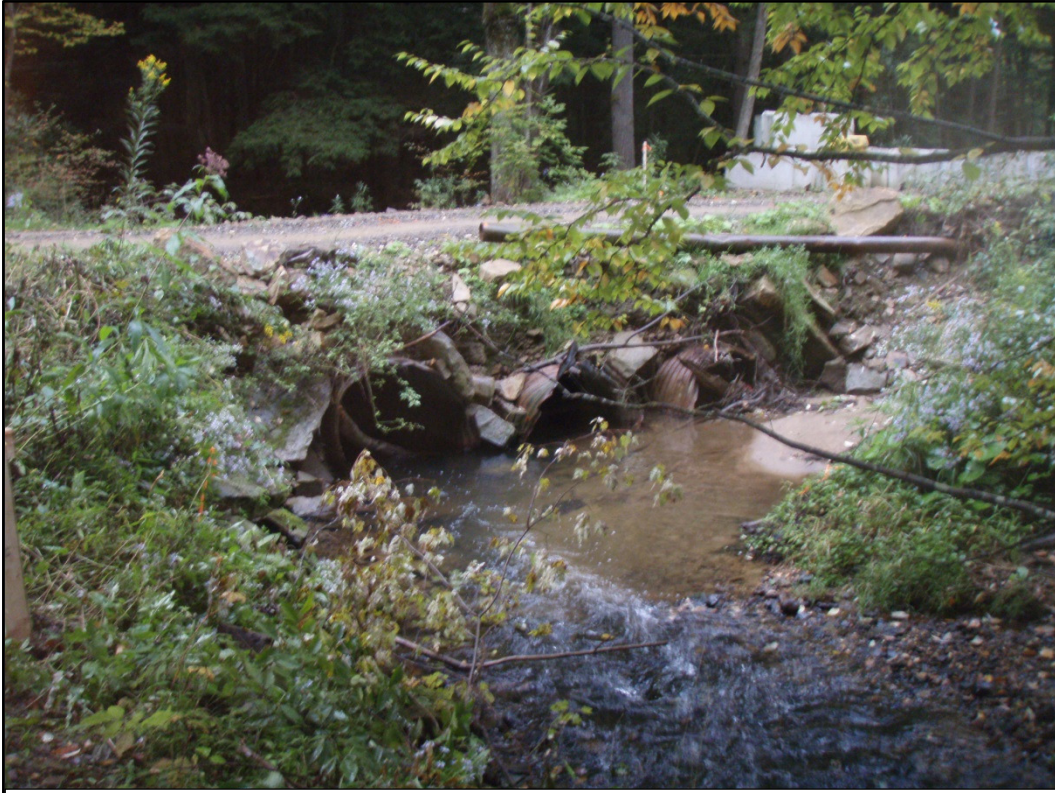
**Forest Road 156 culverts inlet BEFORE restoration**

The three undersized culverts were removed and replaced with a fabricated steel bridge with pine-wood decking. The bridge footers were installed and armored with limestone rocks to prevent scour. The bridge was 14 feet wide and 35 feet long, with 31 feet between the bridge footers to accommodate the average stream width of 20 feet. This increased capacity to accommodate stormwater flows should significantly reduce flooding of Forest Road 156 at this crossing. During removal of the culverts, the sediment bar that had formed in the stream channel above the culverts was excavated and removed. The excess sediment was used to regrade several upland parking areas near the project site. The stream banks and roadside drainage ditches were lined with limestone rocks to inhibit erosion and sedimentation and act as a pH buffer for road runoff. The dirt and gravel road approaches to the bridge were graded and finished with limestone driving surface aggregate (DSA), which stabilizes the road base and surface materials to prevent sediment runoff.

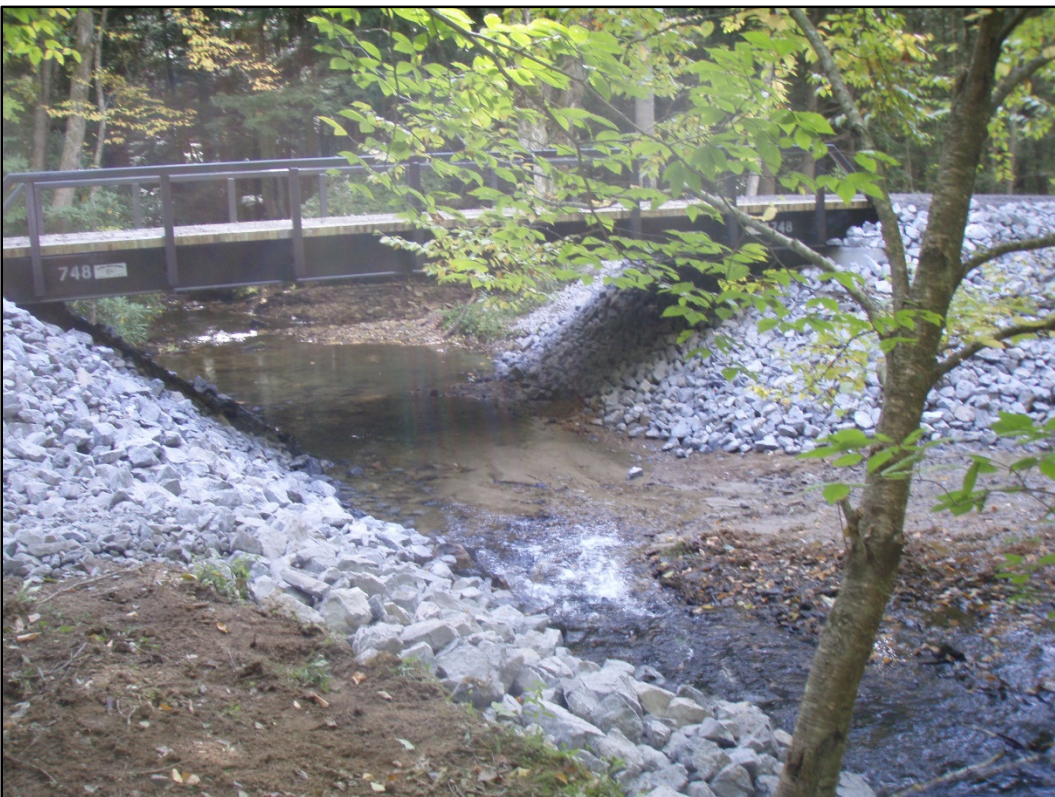
**Forest Road 156 Inlet AFTER restoration**

The project was implemented as originally intended, following the engineered designs for new bridge construction and installation. One slight alteration in the restoration work was encountered where the sediment bar was removed from the right descending bank above the inlet of the culverts. Due to a shallow gas pipeline located in the roadside ditch, the heavy excavator could not be driven over it while loaded with the stone intended to armor the streambank in that section (which was previously excavated by a smaller and lighter piece of machinery). Therefore, stone was only placed as far as the excavator's

hydraulic arm could reach, leaving a small section of disturbed bank exposed. While this bare section of bank is outside of the average streamflow, it may lead to erosion during high water events. Therefore, Western Pennsylvania Conservancy and the Cornplanter Chapter of Trout Unlimited will monitor natural vegetation regrowth on this bank, and are discussing plans to revisit the site in the spring of 2015 to plant or transplant vegetation to this bank to provide additional stabilization.

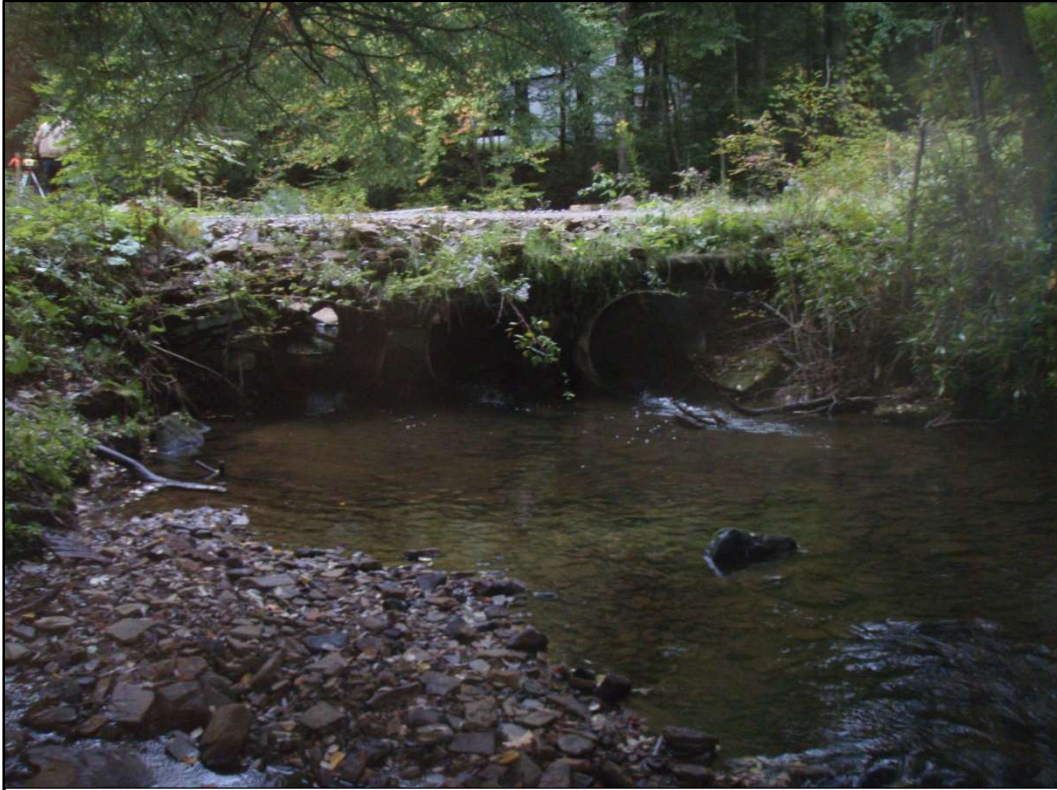
**Forest Road 156 culverts outlet BEFORE restoration**

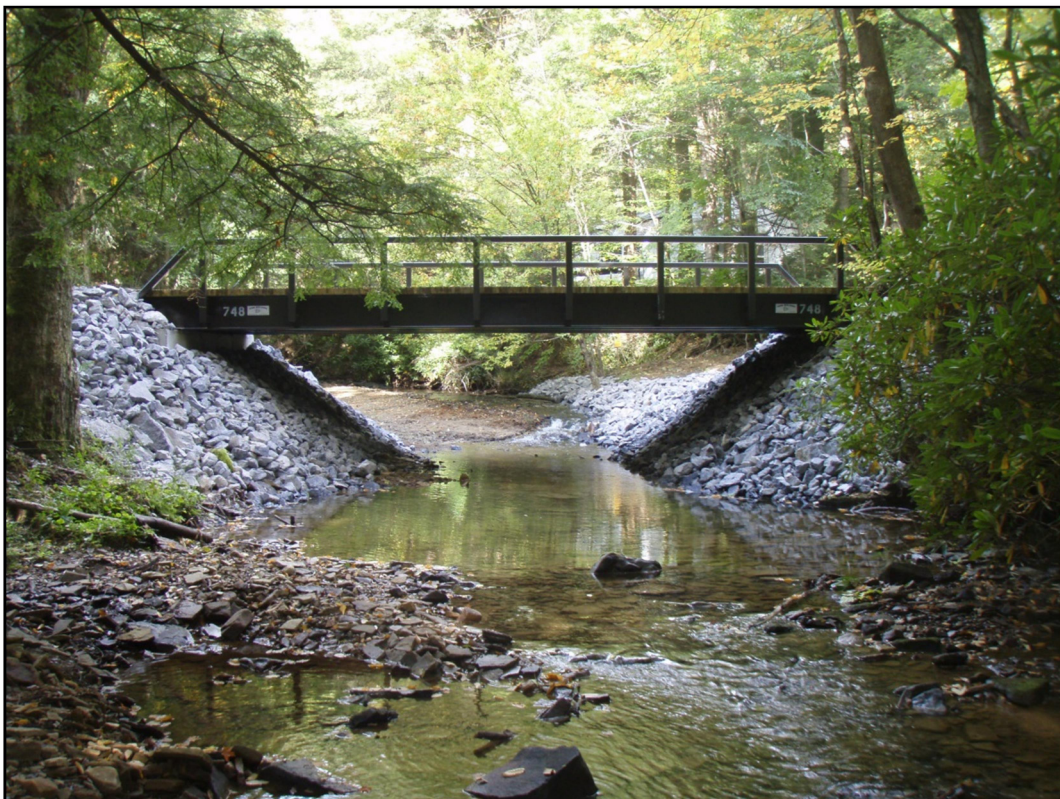
**Forest Road 156 Outlet AFTER restoration**

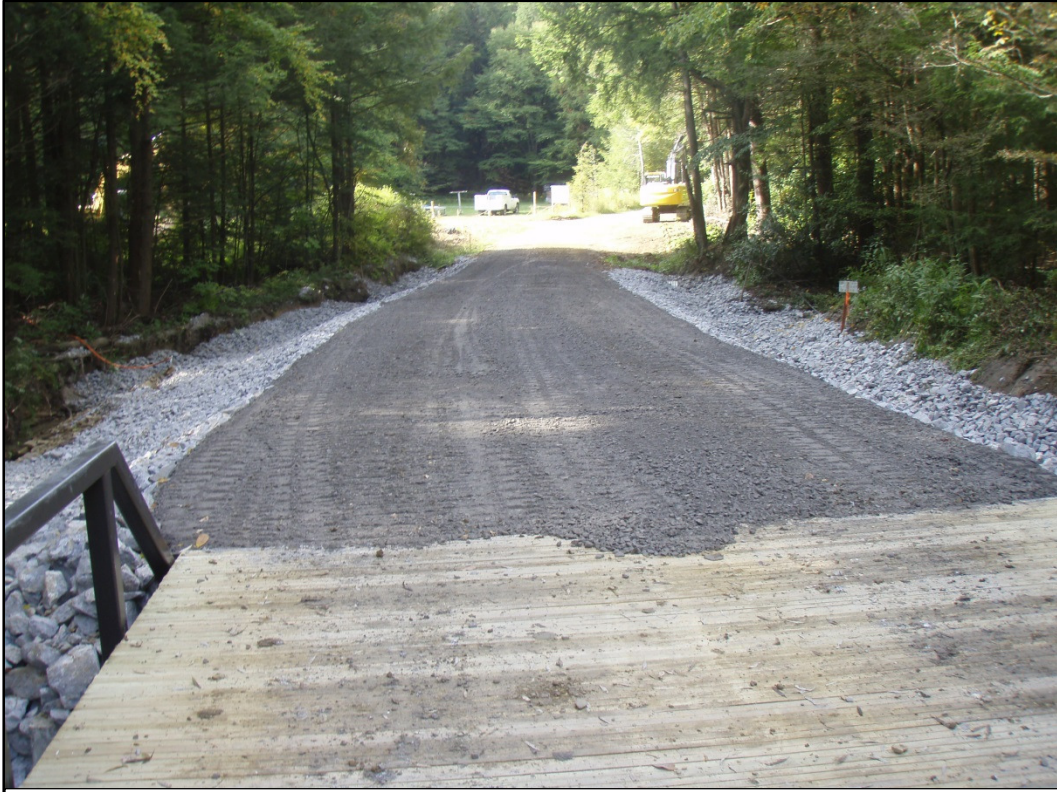
**Forest Road 156 AFTER resurfacing with DSA and limestone ditch lining**
