Implementation Grant Final Reporting

Wildlands Conservancy's LITTLE LEHIGH FISH HABITAT AND RIPARIAN BUFFER RESTORATION 2018 Final Report for Coldwater Heritage Partnership Implementation Grant

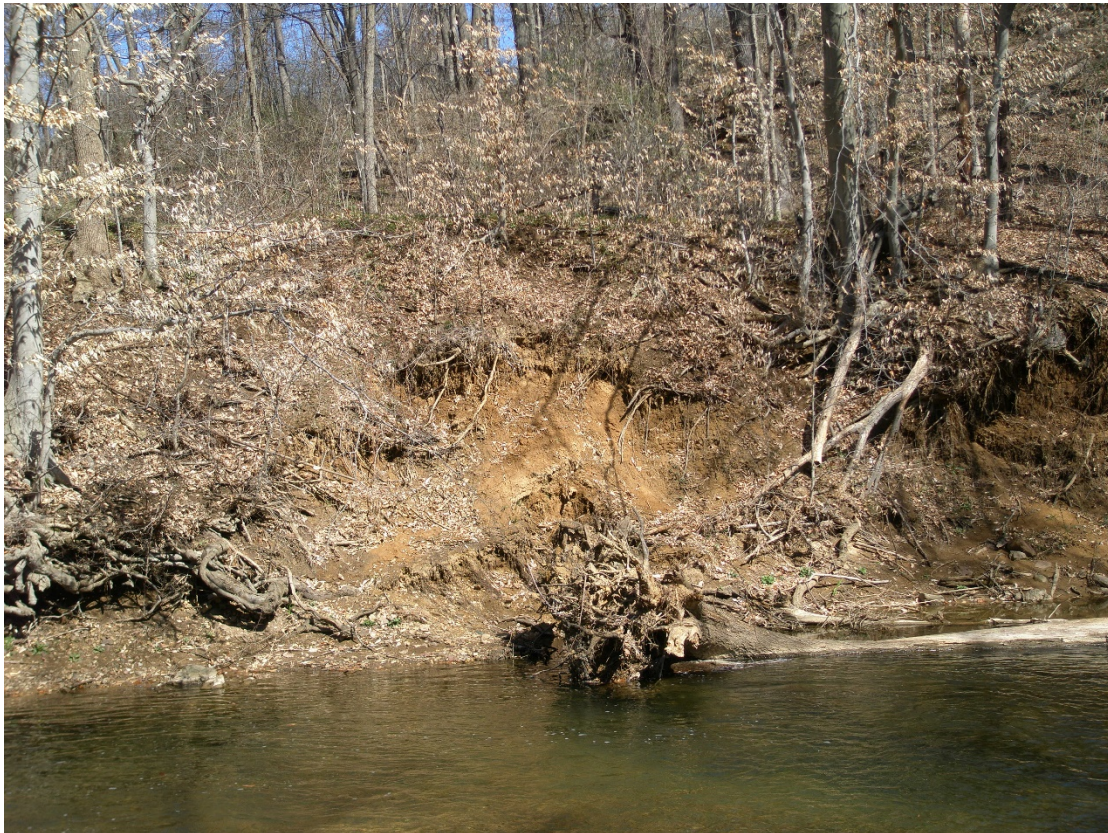
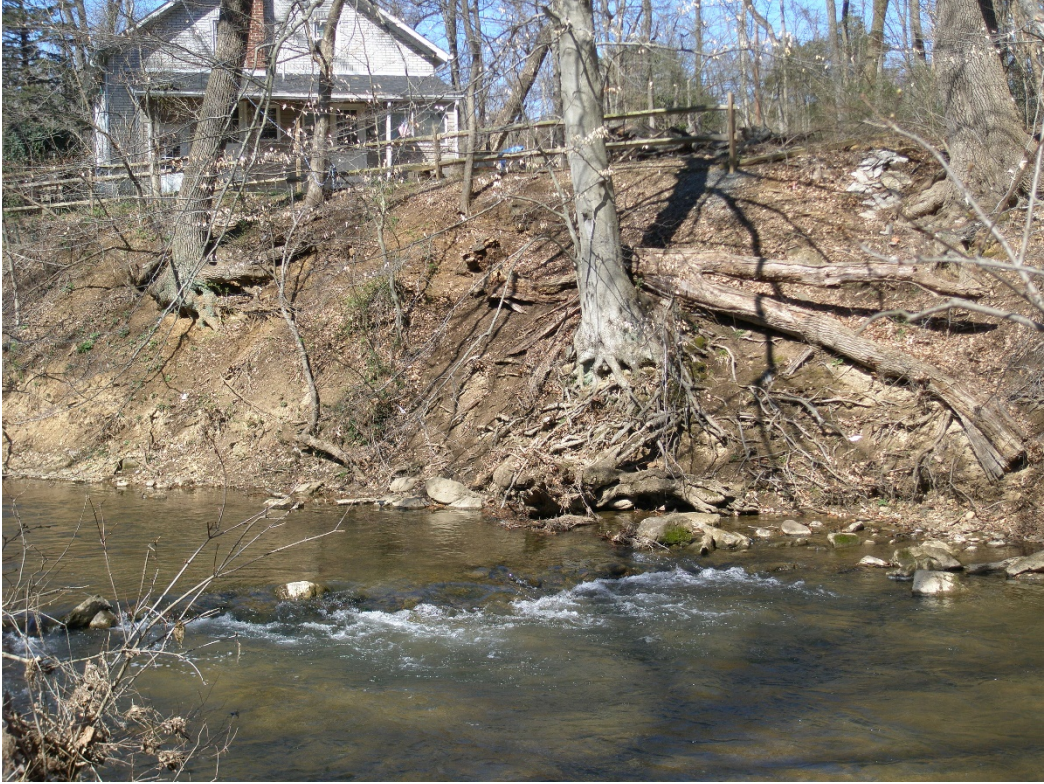
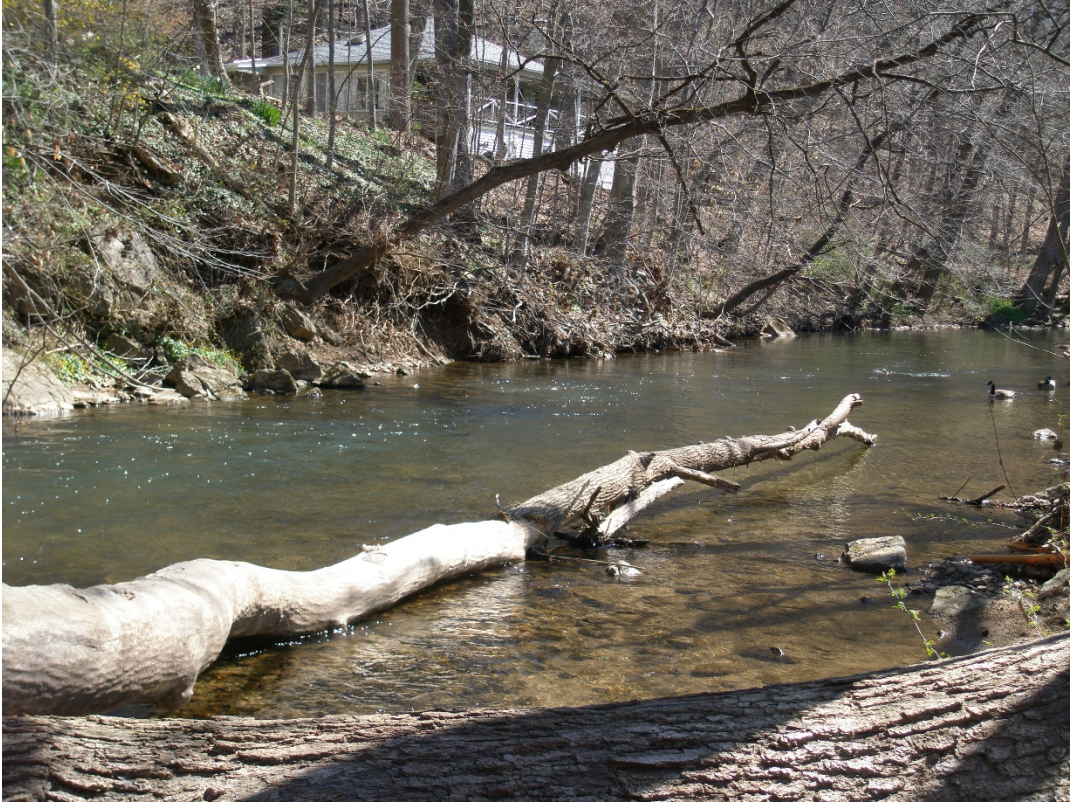
Before:

Little Lehigh Creek is a HQ-CWF fishery and naturally reproducing trout stream, which runs adjacent to the Pool Wildlife Sanctuary. At the point where the stream enters the sanctuary, the access road for the preserve runs atop a steep and narrow embankment. Along this approximately 250-foot reach of stream there is significant erosional pressure in an outer-bend of the stream. The bank instability at this point threatened the access road and numerous mature trees, many of which have already been lost during high water events. Sedimentation downstream from this point was also significant, impacting habitat for a long stretch of stream bottom further into the preserve. Continued erosion at this site would necessitate removal of the emergency access road, and elimination all mature vegetation from the stream bend.

This project stabilized the bank and created in stream habitat improvements, which together will preserve the emergency access, protect the mature vegetation, and provide additional habitat for instream species which support natural trout populations.

The Cottage Lane Restoration project has stabilized the banks of approximately 400 feet of High Quality Coldwater stream. Installations of saw tooth deflectors, boulders and root wad are preventing erosion of steep slopes, loss of mature native riparian trees, decreasing sediment accumulation, preserving the viability of the emergency access road, and increasing the availability of instream habitat.
