**Monocacy Creek Chapter of Trout Unlimited
Monocacy Creek Dam Removal and Stream Restoration Project
Coldwater Conservation Grant Final Report**

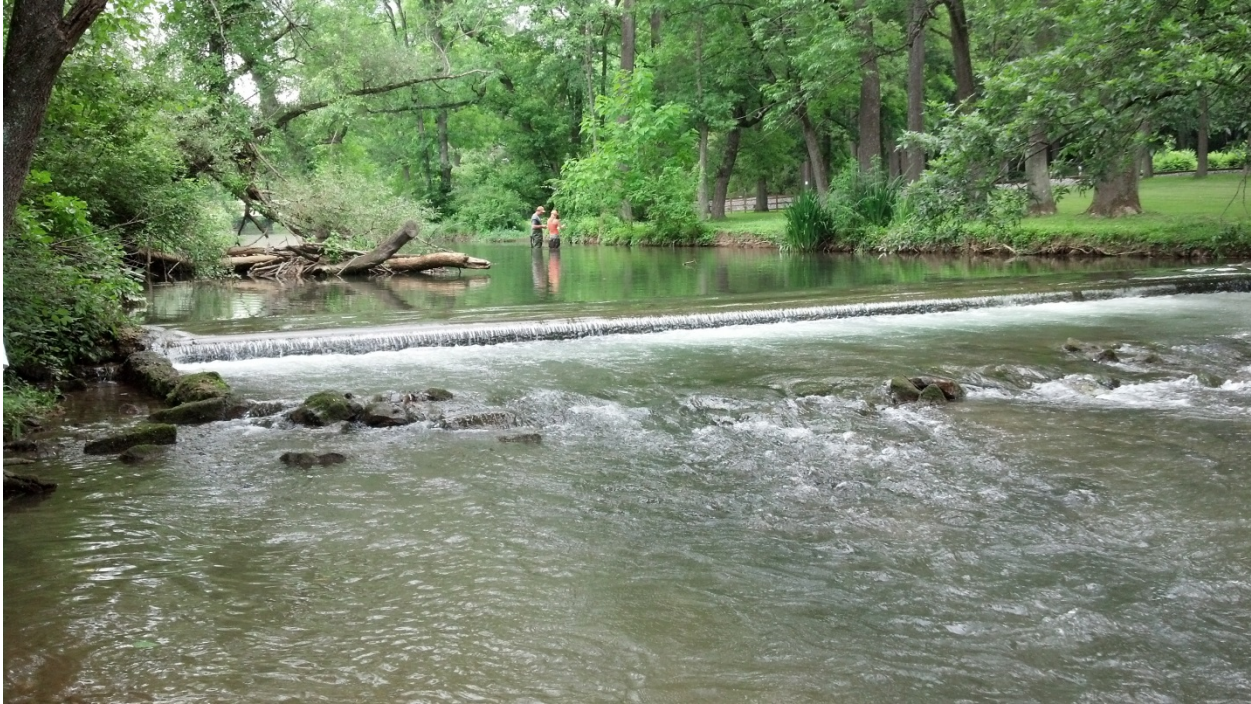
Before project: the dam on Monocacy Creek obstructing flow and degrading habitat.

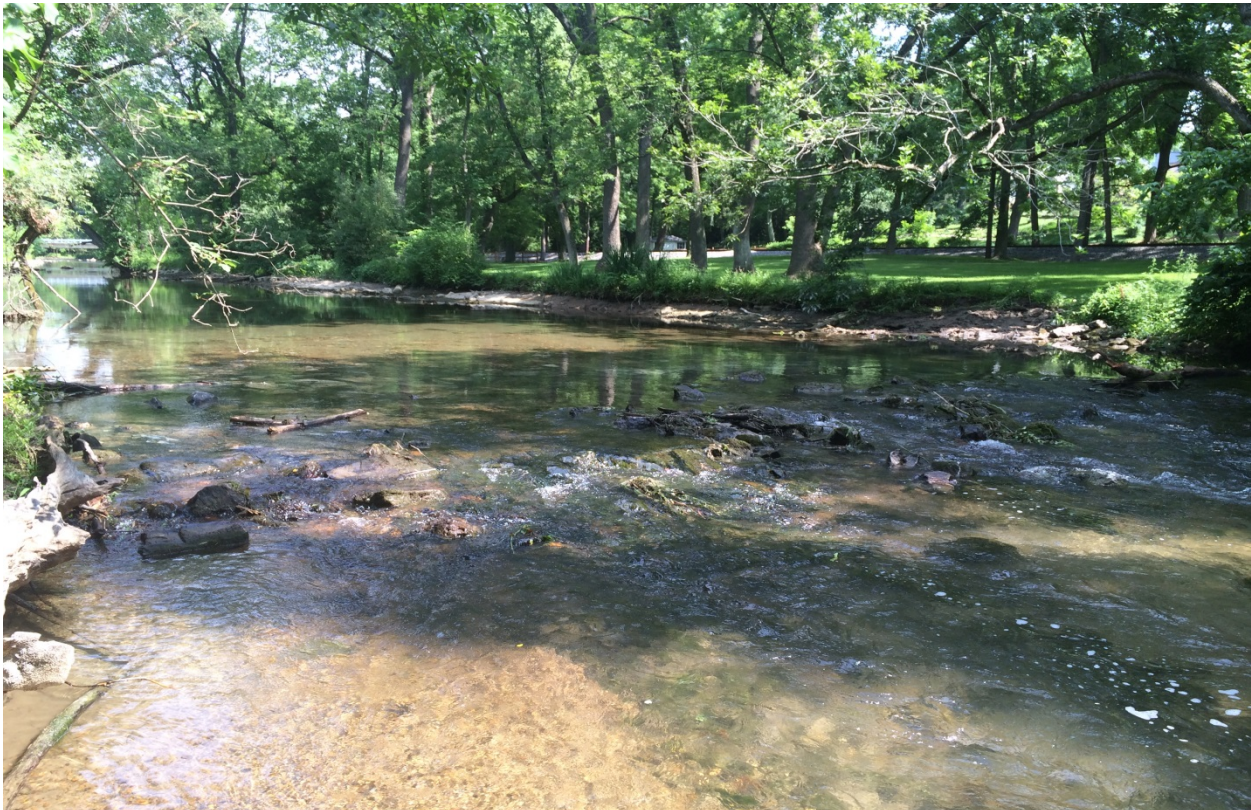
After project: immediately after dam removal in July 2016. A nice riffle now exists where the dam stood and the stream begins to narrow.

We removed the dam and stabilized the streambanks in July, and began seeing immediate benefits. The unnaturally wide and shallow channel created by the dam began to narrow as the impoundment drained. The stream was restored to free-flowing conditions for the first time in

almost 100 years. A few months later, the stream substrate is significantly more exposed as the sediment buildup has begun to clear. More of the bank is exposed and has begun to revegetate now that it is stable. During the first significant rain event following the dam removal, the adjacent properties did not experience any flooding. In the past, the stream would flood well into both properties. A nice riffle now exists where the dam used to be.

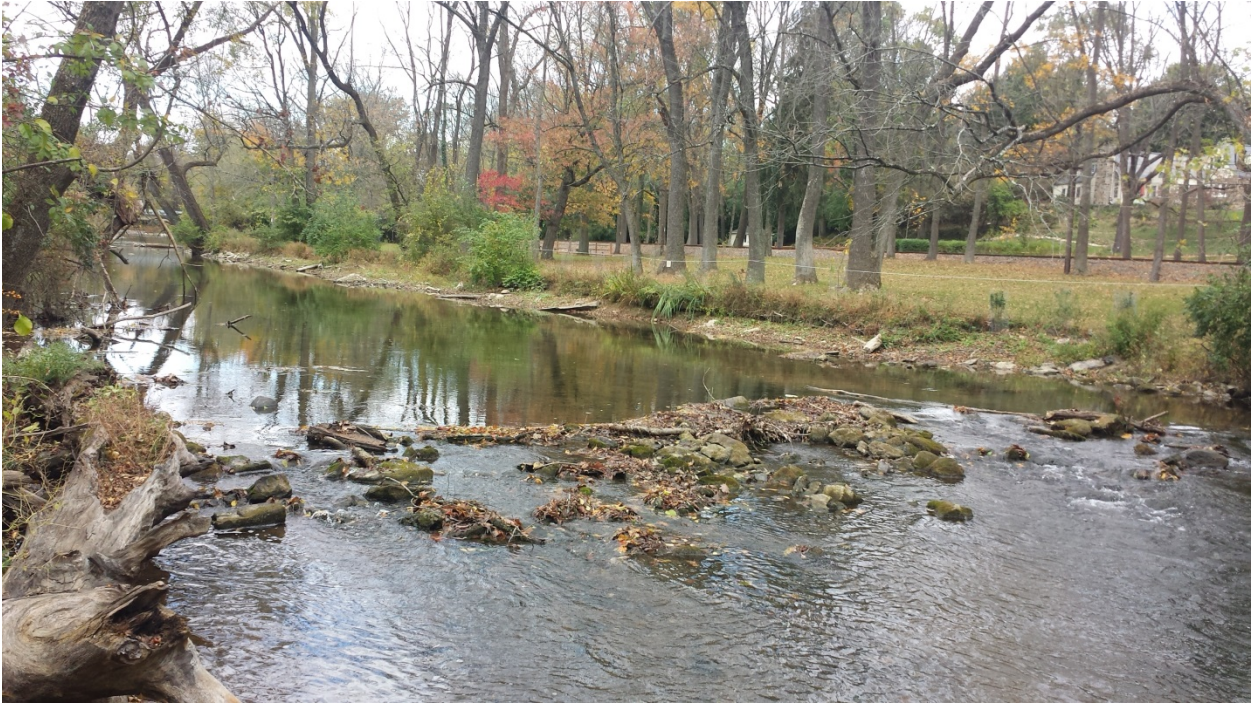
After project: Former dam site in October 2016. More of the sediment has been cleared from the stream bottom, the newly exposed banks have begun to revegetate and the planted shrubs and trees help to continue stabilizing the banks.

There have already been significant observable benefits to the stream since the dam removal in July. The stream has narrowed now that the dam is no longer impounding water and eroding the surrounding streambanks. The buildup of sediment on the stream substrate has begun to clear and expose the gravel and cobble that is suitable for macroinvertebrate and fish habitat. The downstream scour from the dam has been filled in and a natural riffle has taken the place of the deteriorating concrete dam. As the stream channel has narrowed, new banks have been exposed and stabilized. The newly exposed soil has begun to revegetate which has reconnected the stream to its floodplains.

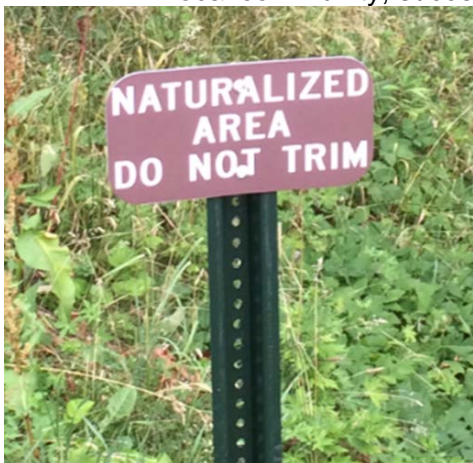
All project objectives laid out in the grant agreement were met. We completed the design and permitting for the project, conducted outreach to the landowners and local community, successfully removed the dam and stabilized the stream banks,

and planted a native riparian buffer along both streambanks. The project is complete now that the stream is restored to free-flowing conditions. The stream channel will continue to adjust to the removal of the dam. The stream conditions and water quality will continue to improve as the remaining sediment is flushed from the stream bottom, and the native riparian buffer continues to grow and provide habitat and shade. The final piece of the project will be completed by mid-November. We will be installing no-mow signs along the edge of the planted trees and shrubs to further protect them and prevent the landowner from mowing the other vegetation that will grow up. Once the signs are installed, the project will be complete.

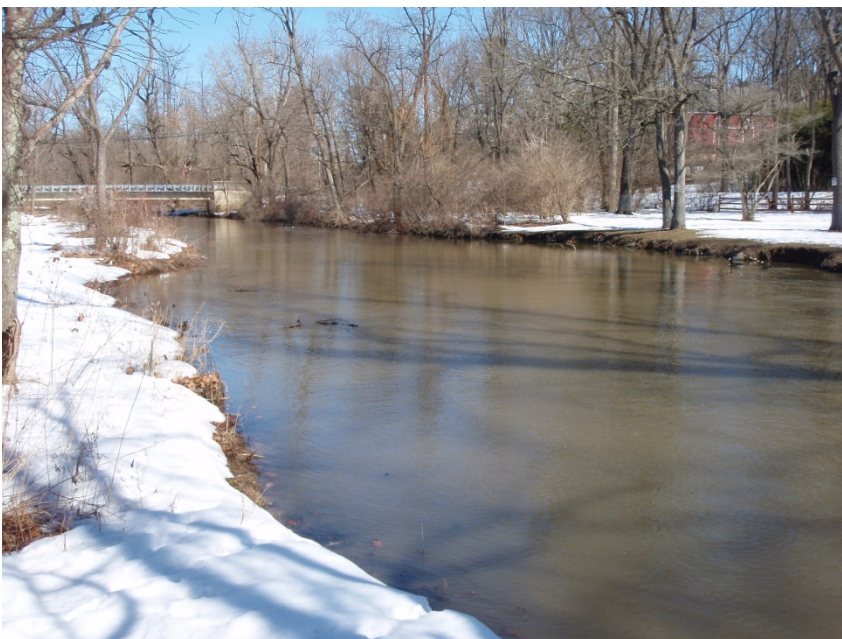
The flat, featureless stretch above the former dam does not provide ideal habitat.

PFBC indicated that the site would be further improved by instream structures. The reach that we worked on is fairly straight, wide and shallow with uniform conditions that do not make ideal habitat. Some structures along the banks and in the stream could greatly benefit native species. These structures would create nice pools and encourage riffles and swift-moving sections.

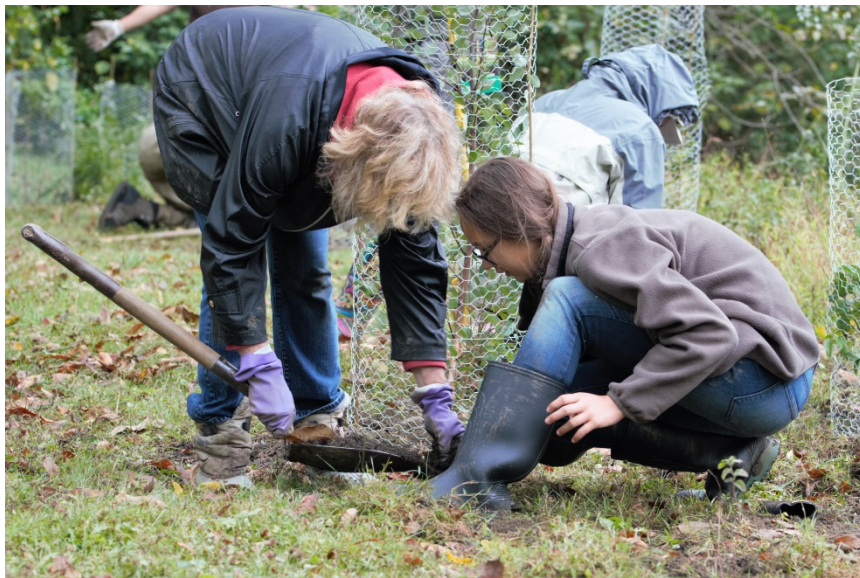
community outreach throughout the project period and was informed about project progress at monthly meetings. The Board also volunteered during the planting event in October. Through the course of this project, the MCWA contributed 30 in-kind hours. The MCWA Board also made the decision at their September board meeting to contribute \$500 of cash match toward the project to purchase additional plants for the riparian buffer.

- The local community was also involved in the project through our planting event in October. Through their volunteer involvement, local community members contributed 27 in-kind hours to the project.
