# East Branch Tionesta Creek

## COLDWATER CONSERVATION PLAN

McKean, Warren, and Elk Counties

May 2017

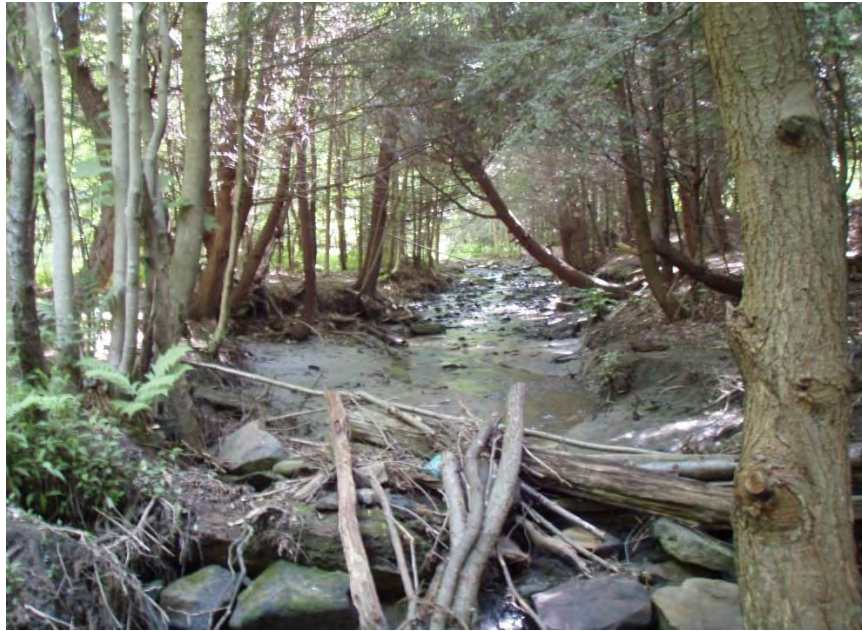
*6099: The riparian area of this segment is periodically used by the local high school to create habitat for small birds and mammals. Incorporating stream habitat into these events to address the entire riparian ecosystem would create greater ecological lift, as well as a more well-rounded learning experience.*

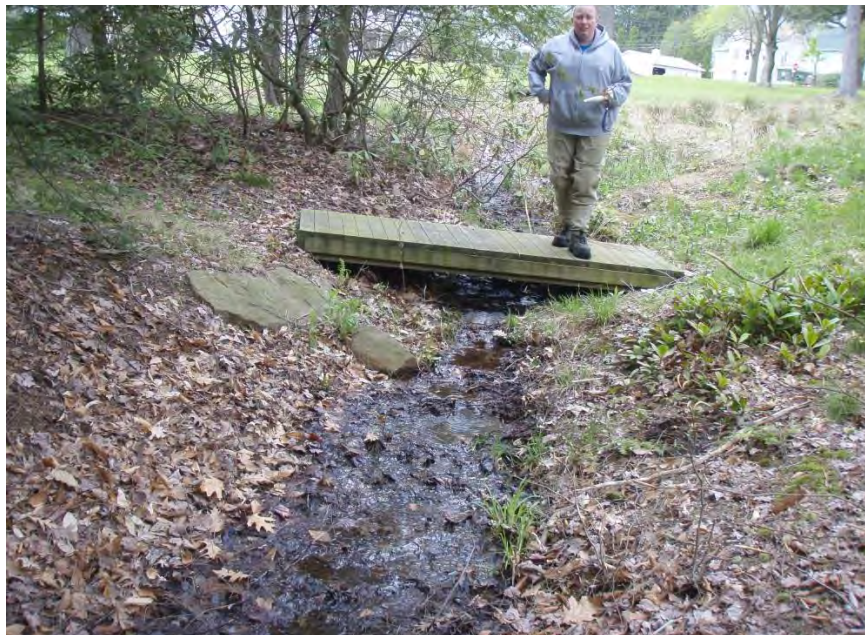
6090: Checking pH, conductivity, and temperature.

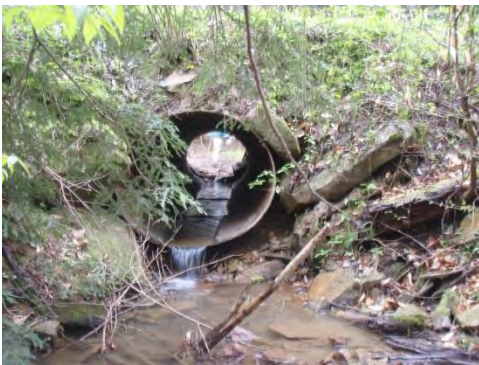
*6203: Perched culvert on private access road (left), three pipes on relic logging road (right).*

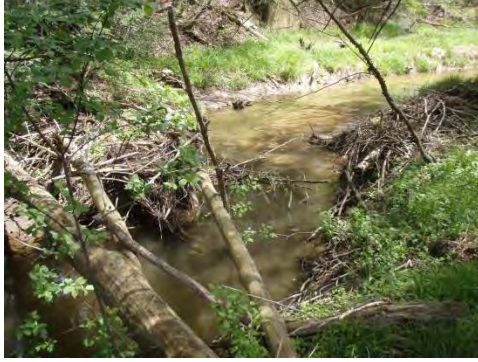
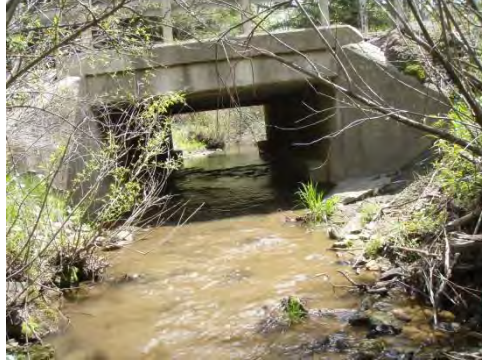
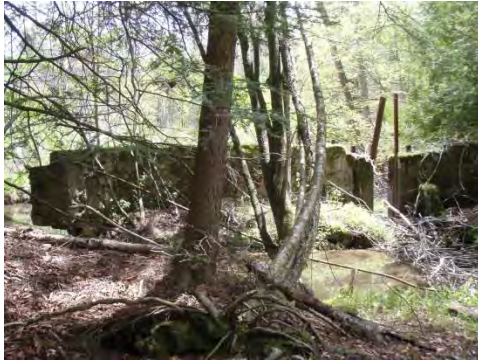
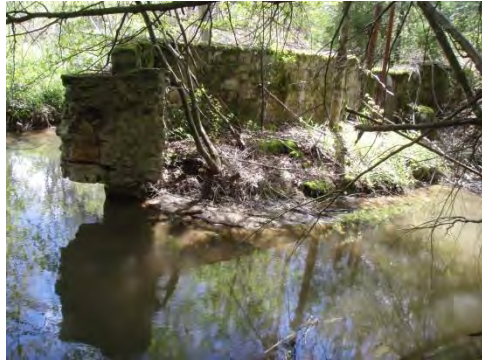
*6231: Clockwise from top left: Relic, breached dam upstream of State Route 66; box culvert on State Route 66-minimal floodplain development inside; Relic, breached dam downstream of State Route 66; another view of the same breached dam downstream of SR 66. These dams are partial/minimal AOP barriers.*
